# **Joint Sector Program proposal (in regard to Step 1 of the ToR) for the ERA Task Force on wagon/axle maintenance**

*JSSG for ERA Task Force on wagon/axle maintenance*

*17<sup>th</sup> December 2009*

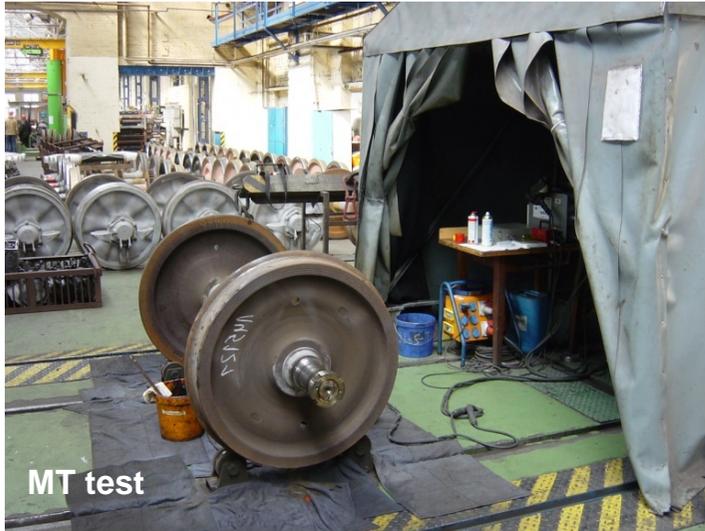
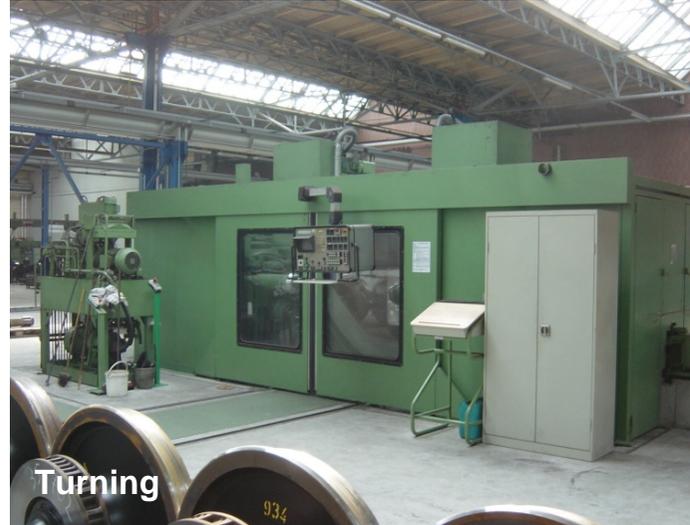
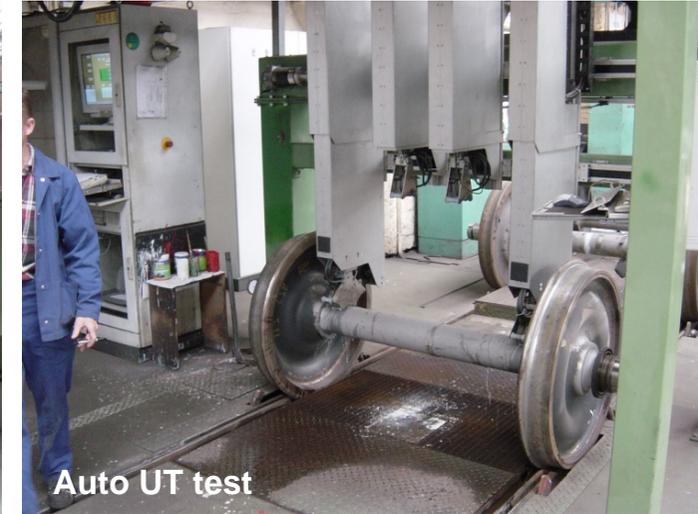
## 9. Improvement of wheelsets and axles maintenance in the past years

The Sector reminds that, even in the past, there has been a continuous improvement in freight wagon axle maintenance (procedures, measures,...) in several railways and private wagon companies according to findings in maintenance or after incidents. The Sector has so always improved to prevent similar irregularities, but not in a harmonised European way.

Examples are the introduction of additional NDT after detection of corrosion, partially improved NDT technologies as Auto UT, MT, ECT, training programs, introduction of special conditions for corrosive traffics, partially shortening of the wheelset revision periods, additional treatments on the axles,...

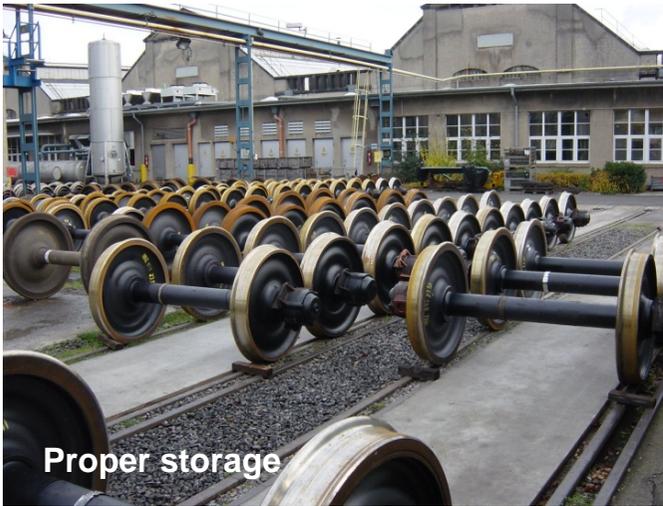
Proper storage

Even the traceability of the wheelsets and axles (centralised databases,...) has already started in some companies. Additionally, most companies in the sector perform, in respect of their responsibility for safety, a certification / audit of the wheelset workshops (in different ways). An improvement of storage and handling of the wheelsets was done in parallel.

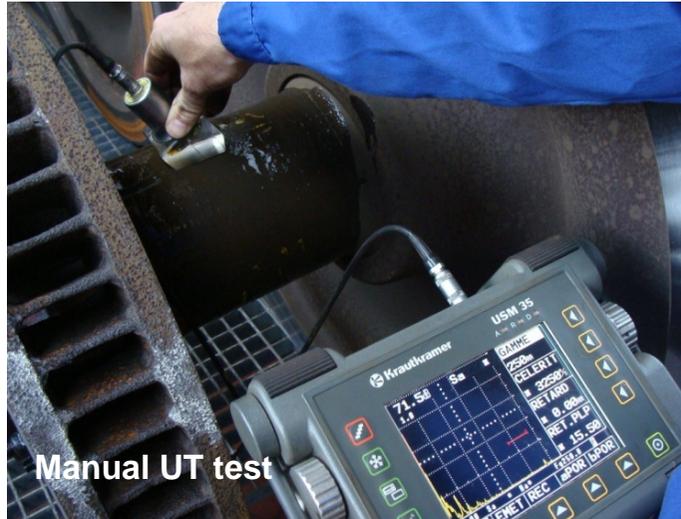
Manual UT test
