# EUROPEAN VISUAL INSPECTION CATALOGUE (EVIC) FOR FREIGHT WAGON AXLES

**to be applied in light maintenance of freight wagons in workshops**

*Joint Sector Group for ERA Task Force on wagon/axle maintenance*

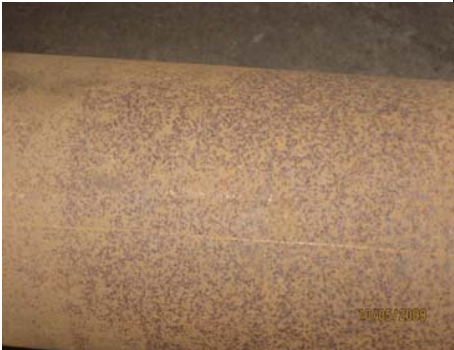
40 No defect - admissible surface appearance		Unpainted axles
Salient information:		
	There exist maintenance rules that do not require any anti-corrosion protection. Axles and wheels stay unpainted in such cases and show a thin and uniform layer of rust on their surfaces in service.	
	SNCB return on experience proves that application of such an axle maintenance system does not lead to any fatigue caused ruptures during service of an axle.	
Decision:		
	Deep corrosion is not accepted.	
	Leave in service wheelset “as new”, “very good”, “good” and “acceptable”	
	mark 1 at “ok” column in EVIC logging	OK

<b>Pictorial representation:</b>			
As new	Very good	Good	Acceptable

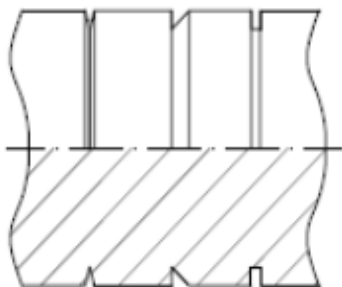
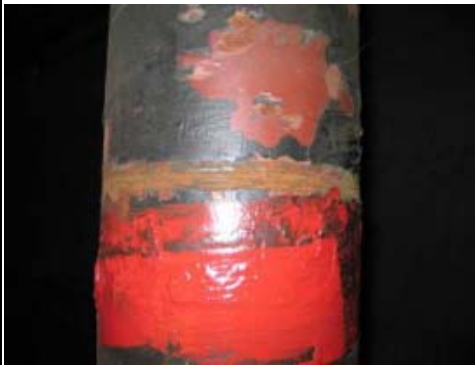
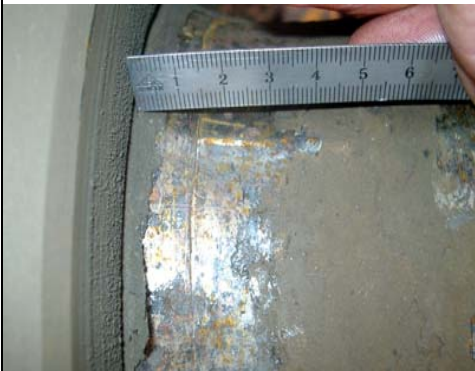
<b>Pictorial representation:</b>

41 Mechanical damage – sharp edged circumferential fluting			Unpainted axles
Salient information:			
	Flutes are characterised by sharp edged circumferential sharp-edged transitions.		
	Mechanical damage to the base material in the form of fluting is inadmissible.		
Decision:			
	Check on the wagon why this damage could have occurred and repair accordingly		
	Remove from service according		Case A
	mark 1 at “X” column in EVIC logging		X
